EAST YORKSHIRE RIVERS TRUST

Newsletter 13 - April 2020

QUINTIN BOTTOM PLANTATION

Tree removal and replanting of 4.6 hectares of land near Lowthorpe Beck

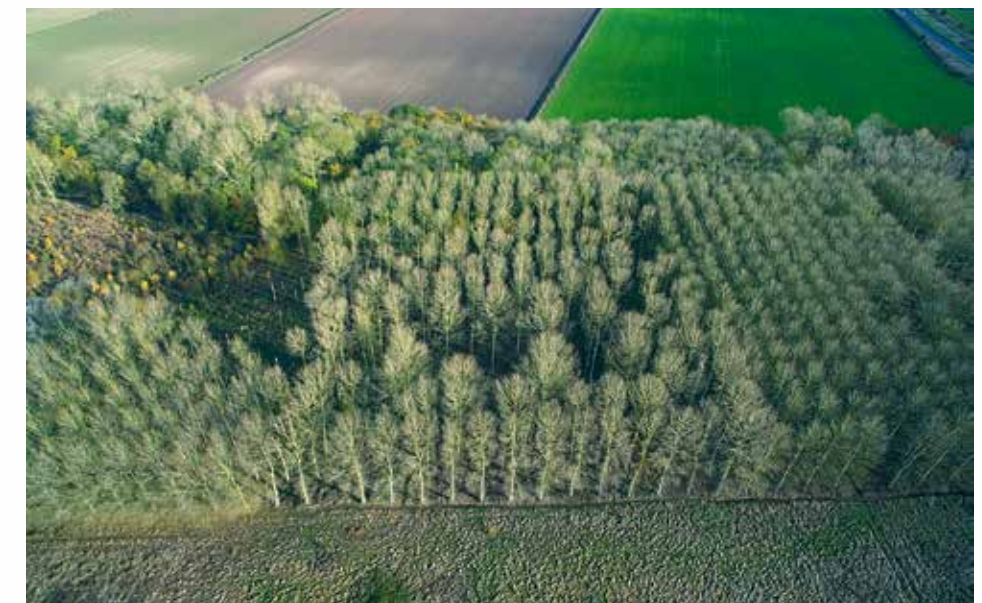
Aerial photograph of the woodland prior to felling. The open area seen on the left is where the trees were killed by insect attack some years ago. These were left as habitat for insects/birds etc.

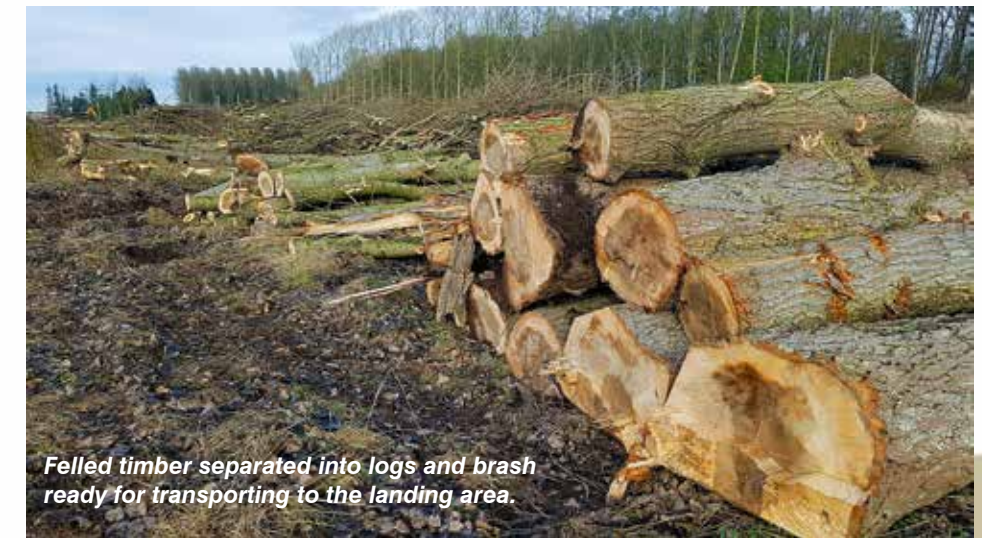
Felled timber separated into logs and brash ready for transporting to the landing area.

The timber has little commercial value and is to be used in the biomass industry.

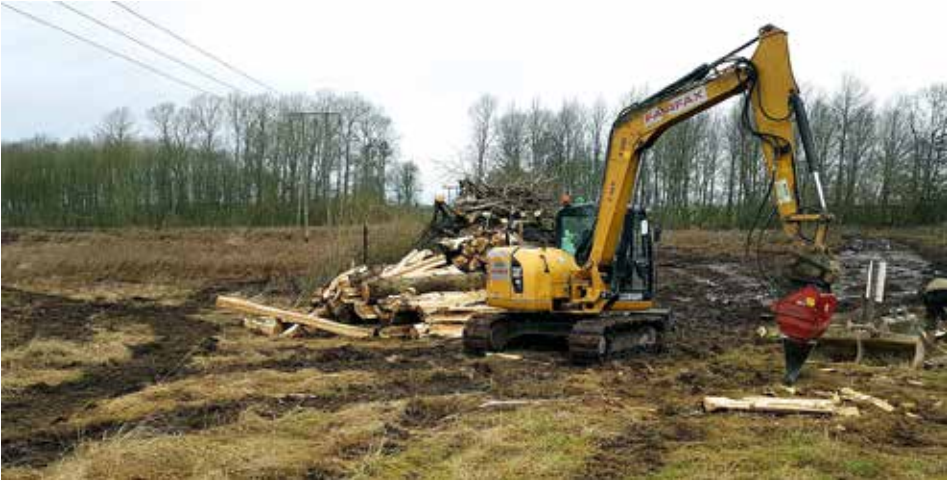
Logs above 16-inch diameter were cracked to assist the drying process.

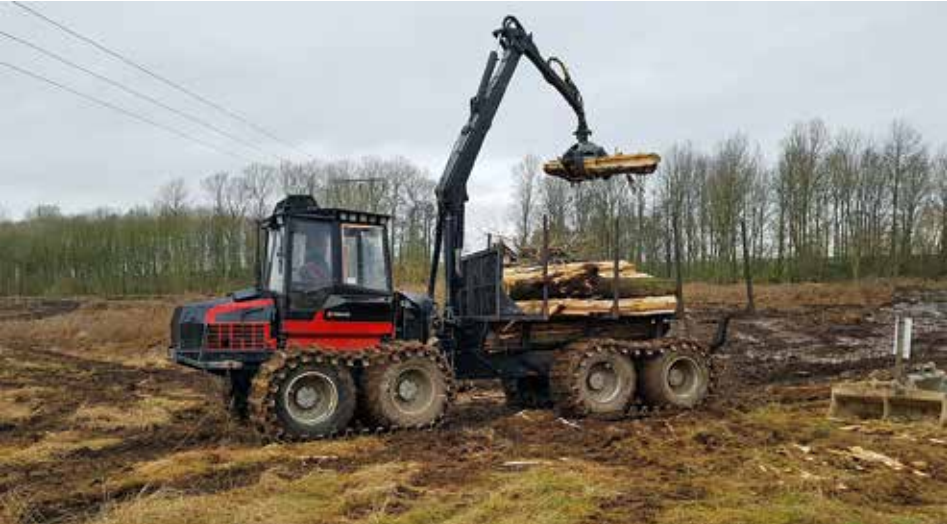
Low ground pressure 'forwarder' being used to move logs up to the landing.

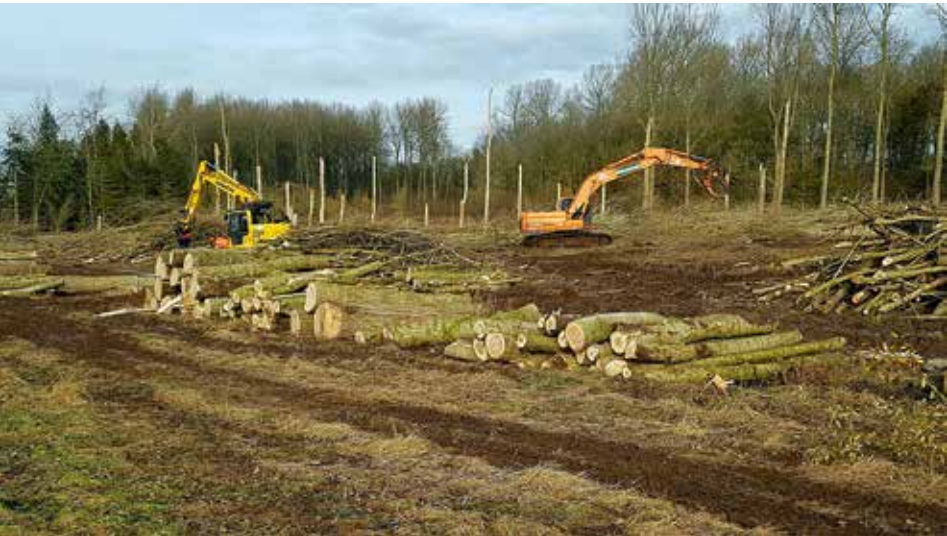
Two 360 excavators working to clear the site of logs and brash. Note the 'standing dead' trees in the background. These are being preserved to benefit insects and birds such as woodpeckers.

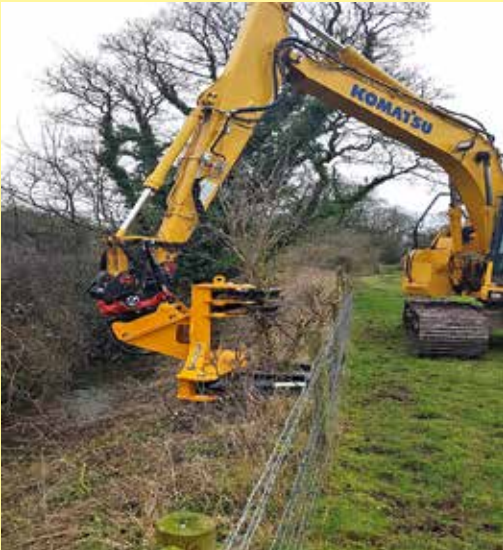
Trees being cropped allowing increased light to the stream.

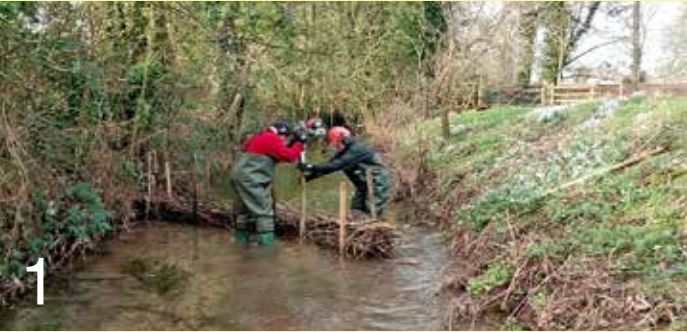
Hazel bundles being fixed with posts and wire. Note how far the new meander line is changing the course of the stream.

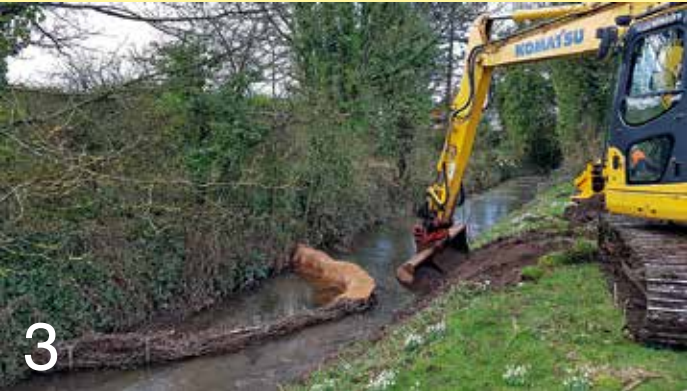
Leading edge of the new meander protected with coir sheeting, and the machine begins to transfer material from the left bank into the meander enclosure.

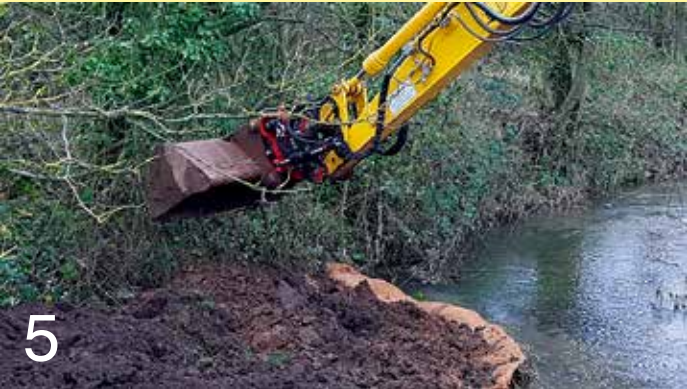
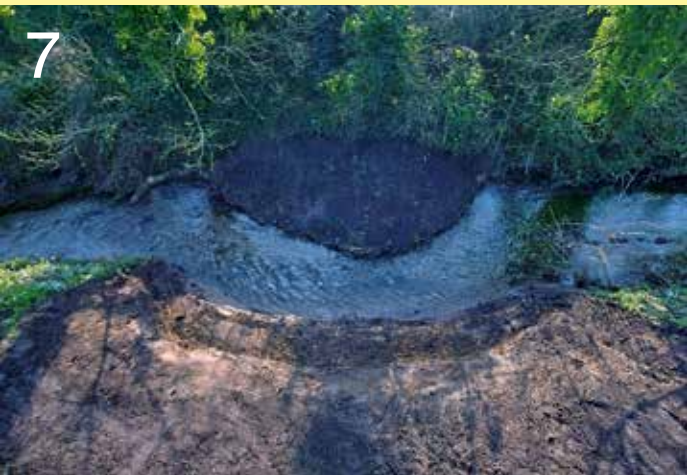
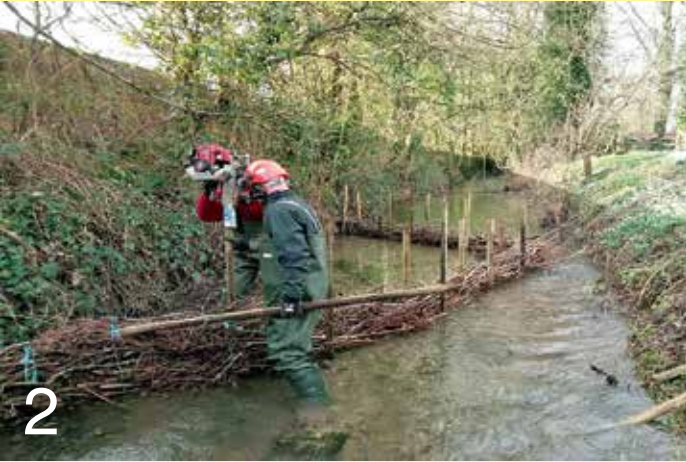
The new meander line being completed as it returns to the right bank.

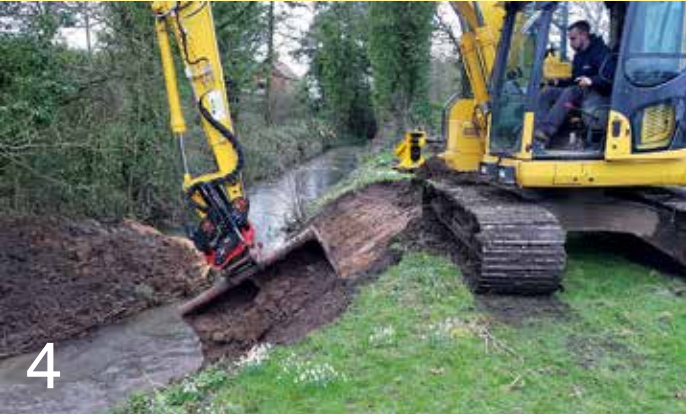
Above: Special fitting allows the contractor to swivel the bucket to shape the new bank
Left: Backfilling the new bank. The material will be allowed to settle prior to seeding with a conservation mix.

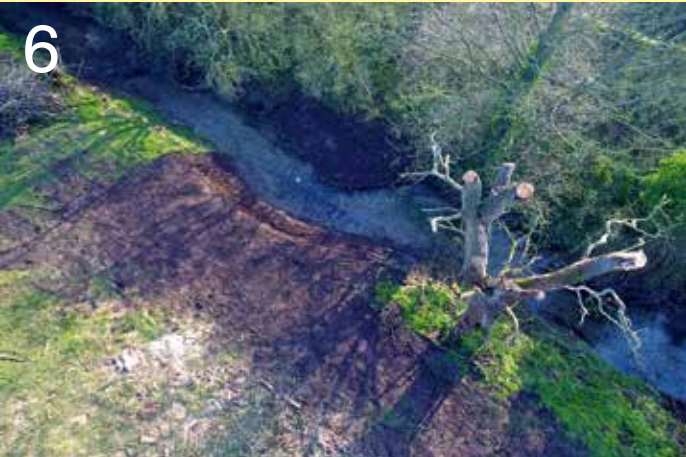
Above: Aerial shot of the upper meander showing the standing dead willow. This tree was crown reduced and made safe. It will benefit wood boring insects and birds
Left: Upper meander – note low level ledge to accommodate high-flow conditions and zone for marginal plants. The new works will be monitored over a few years to address any unforeseen erosion that may develop.

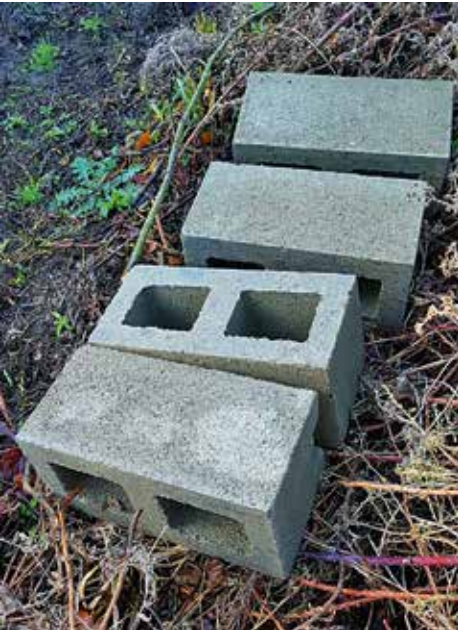
Brushwood bundles were built from alder cuttings collected from trees around the Mere. Samples of the hollow concrete blocks used to construct and anchor the bundles to the lake bed.

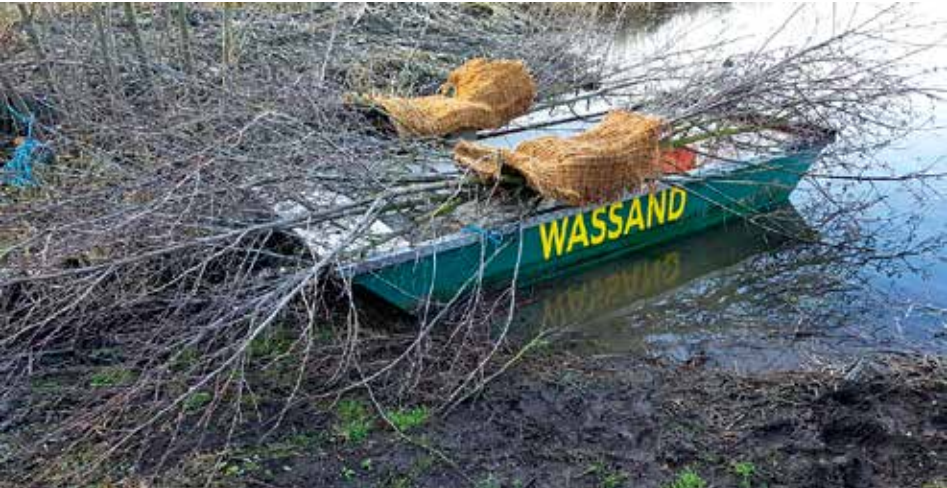
The holes in the blocks were filled with the brash forming a rigid structure about four metres long. The use of a looped coir textile was added to mask the block and provide additional cover. At the chosen location the blocks were rolled overboard. Water depth at the site was 0.5 metres above summer level. It is estimated that the depth around the brushwood bundles will be about 1.5 – 2 metres deep in late spring or early summer. The site is on a sheltered north facing shore with the nearby marginal reed bed consisting of lesser reedmace and phragmites. In total 8 x 4 metre bundles were installed making about 35 – 40 metres of fry/fish cover. The Trust will undertake a mid-season survey around the structure to ascertain the effectiveness of the installation.

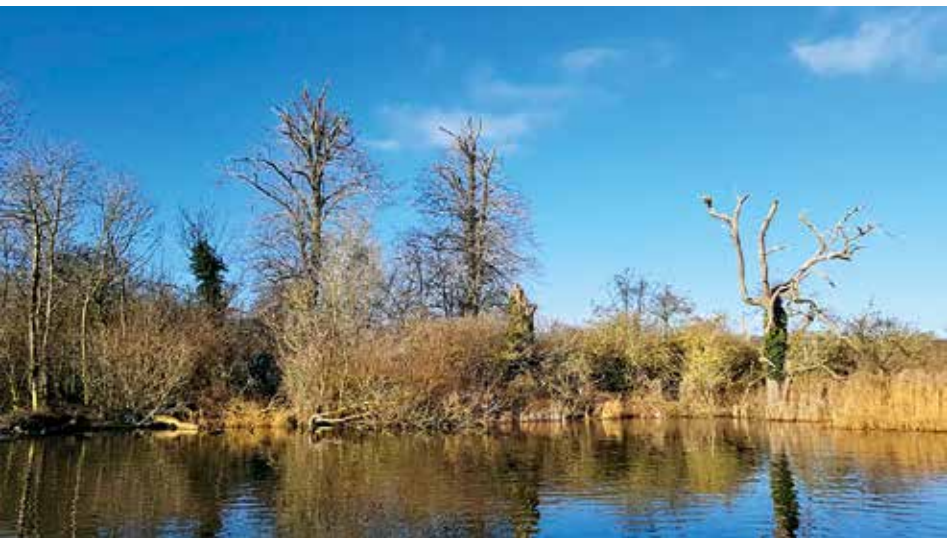
The above image shows the main two cormorant roosting trees – both dead alders. Both of these were felled towards the mere. The tops of the trees, once felled, created valuable cover for the fish. The dead tree to the right of the picture, also a roosting site, was left untouched. A further four alder trees on Lady Island were also felled into the mere creating a very large shelter area for fish. Dense willow planting on the south shore was also hinged into the water. Left: This alder was hinged onto previously felled trees to force the branches under the water. The live, hinged trees will continue to grow providing long term habitat for fry and invertebrates, and there is an option to build on this project in following years as the minor amount of habitat achieved on this occasion is quite insignificant on such a large body of water.

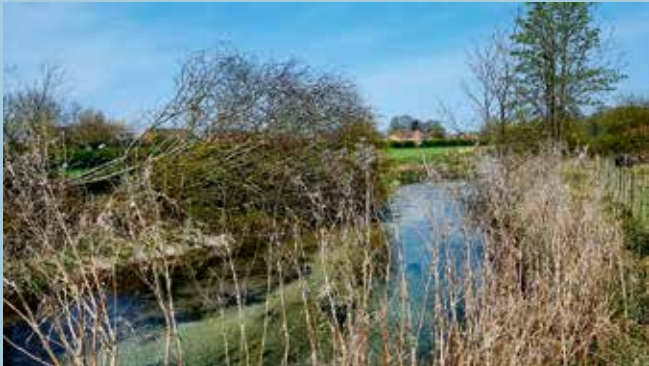
Looking downstream the eroded left bank has become very narrow and could take out the fence line.

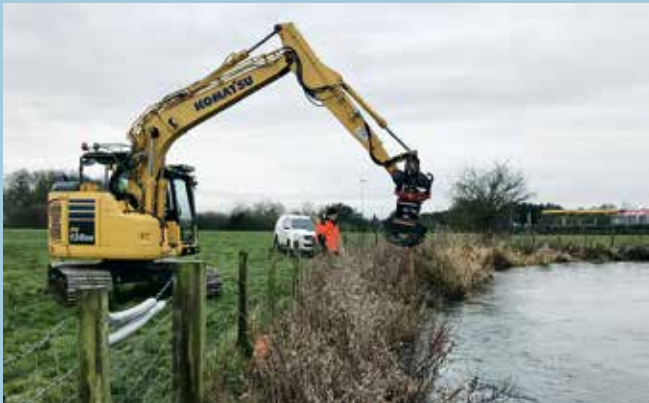
The unwanted limbs and brash were removed from the fallen willow and winched across the river. This material was sorted and long sections kept for the bank revetment. The posts to retain the brash were pressed into the river bed using the machine.

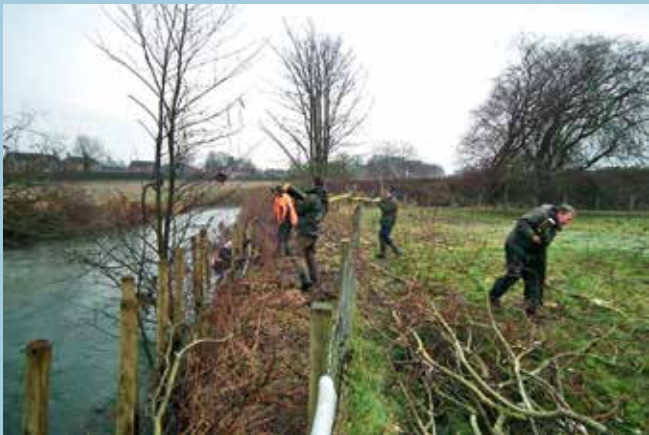
Long willow brash was placed and woven through the stakes. Volunteers from the angling club and YWT helping on site. Several large logs were stockpiled for use as deflectors to be used when river conditions improve.

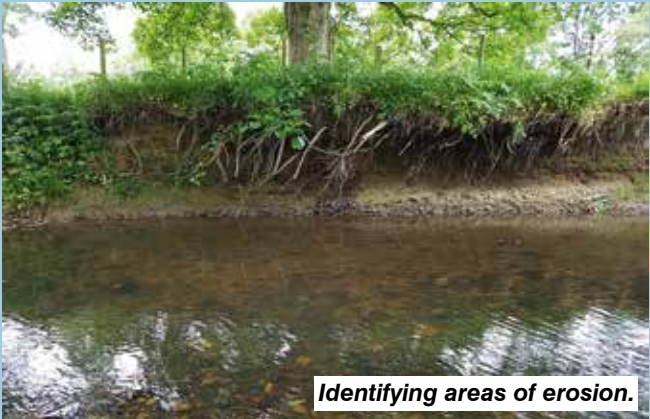
Identifying areas of erosion.

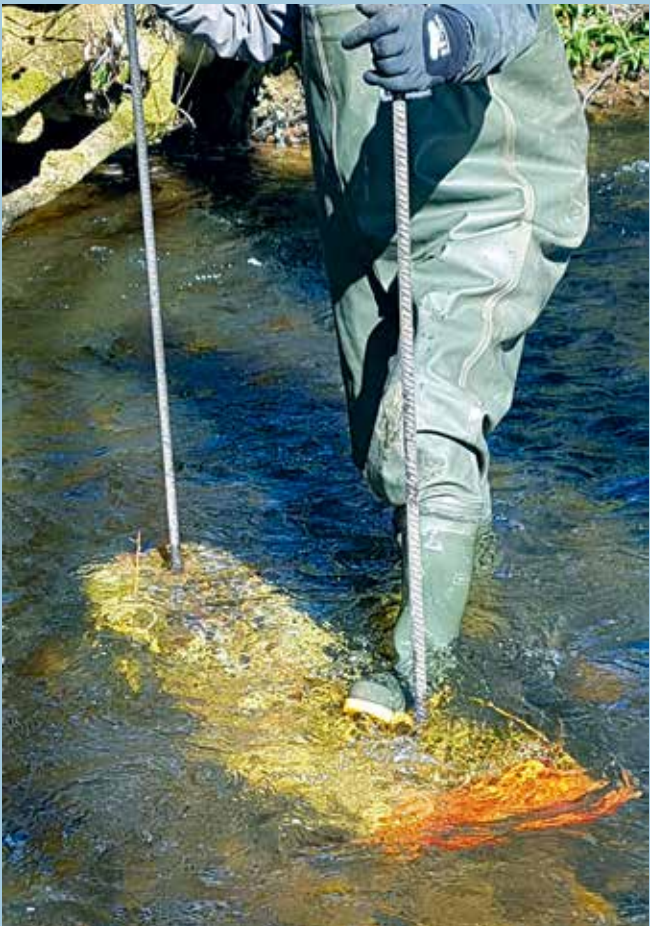
Method of fixing logs (deflectors) to the river bed.

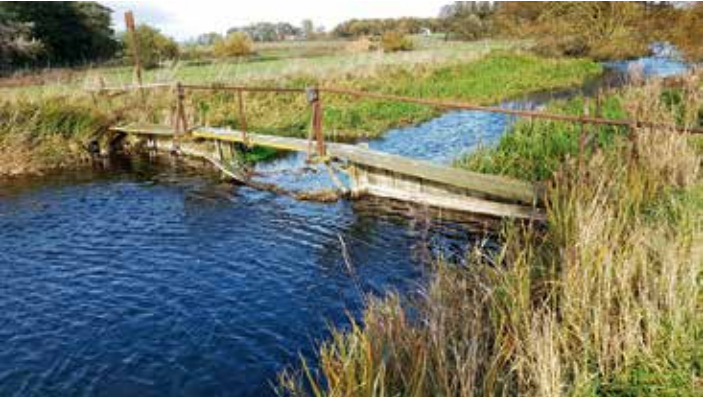
Much of the structure was in poor repair and since its construction had caused heavy siltation upstream towards the Foston millpool.

The defunct steel pile weir prior to work commencing.

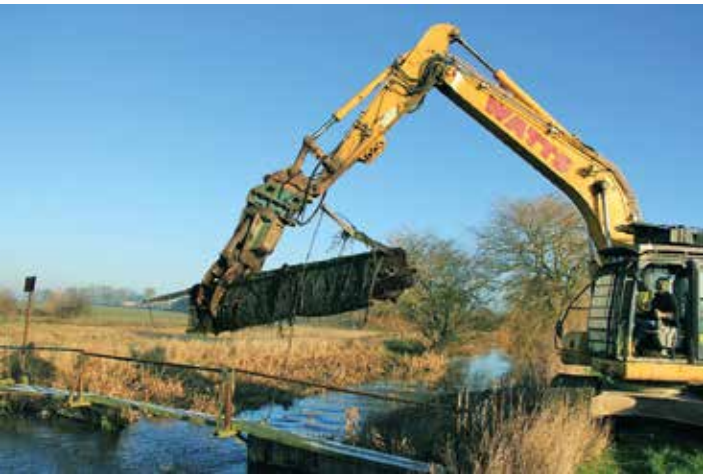
The central screen section removed along with toe boards and stone work.

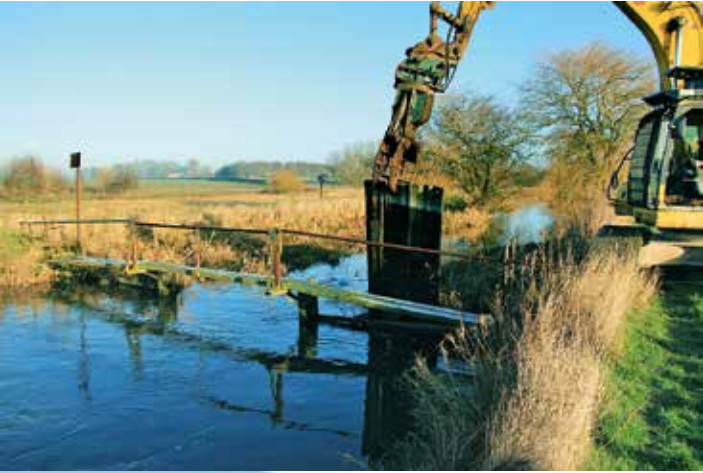
The sheet piles being lifted. It was noted that the piles were not driven very deep and could have given way at any time.

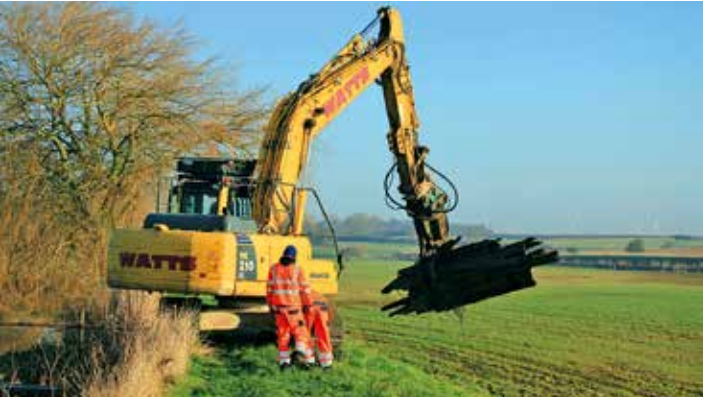
The machine could not reach the small section across the river, but it was decided that the removal of two out of the three piers was equivalent to the average river width. The reed bed fringe was covering the remaining piles. The steelwork was crushed by the machine and carried to a point where it could be recovered by the contractors. It was estimated that the removal had lowered the water level by up to 10 cm. This was not apparent near the weir site but was clearly visible upstream. A discernible increase in flow velocity was also noted and some marginal silt beds had become exposed.

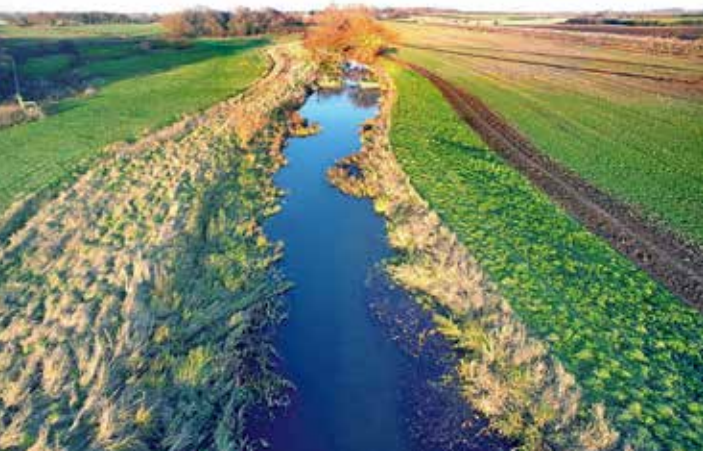
The above image is an aerial shot looking upstream, taken from 30 metres above the Foston Beck and White Dyke confluence, showing the potential natural meander forming.

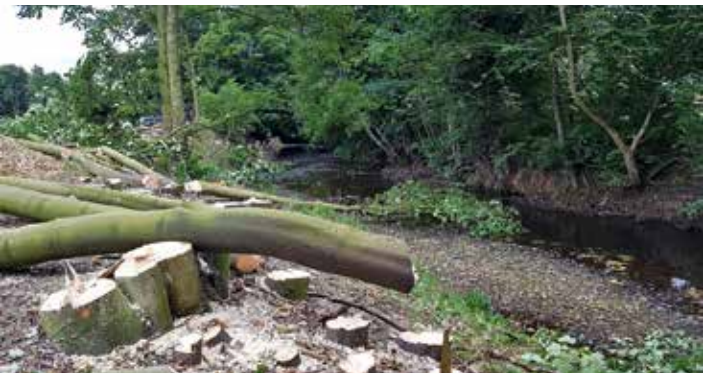
Note gravel bed exposed due to low summer flows now in full daylight. Many of the trees were multi-stem ‘pollard re-growth’ from previous clearance operations. The species involved were mostly alder and sycamore.

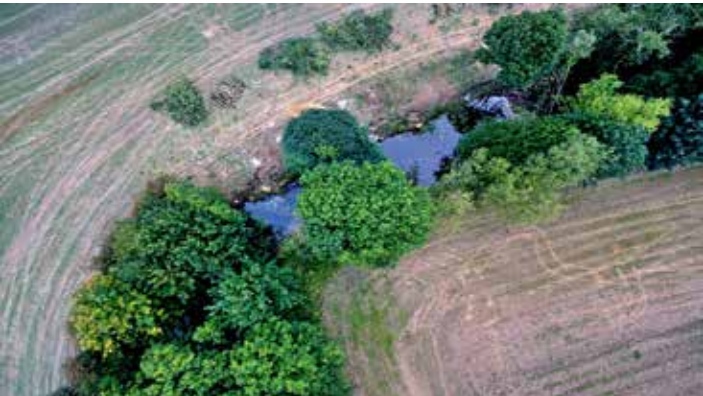
Aerial view showing cleared section. Brash and logs were separated for machine handling.

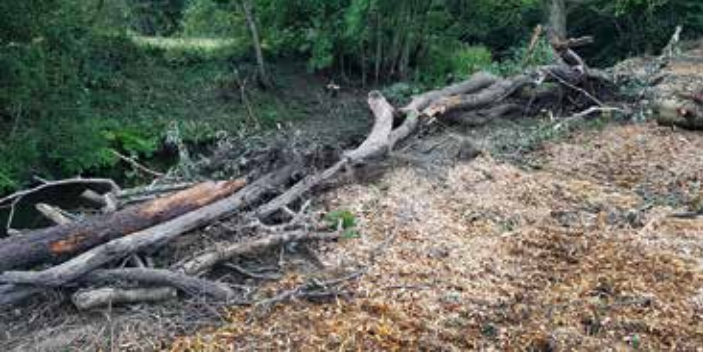
Old timber removed from the river bed during the operation was stockpiled on the bank ready for future LWD projects.

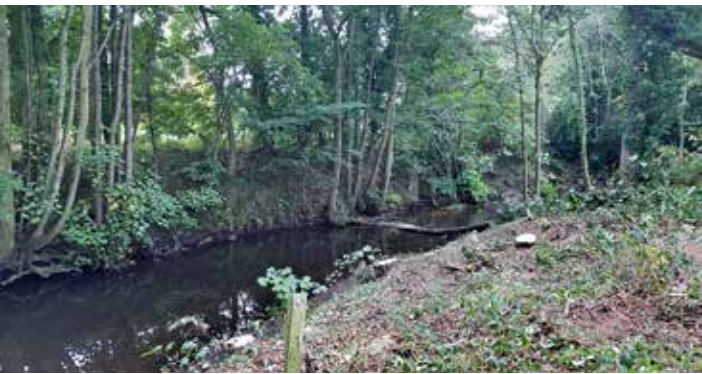
Looking upstream to the Sinnington WWTW outfall. Old logs were left in place as the bed scour and deep water created is beneficial to fish and invertebrates, especially at low flows. These structures were checked and made secure.

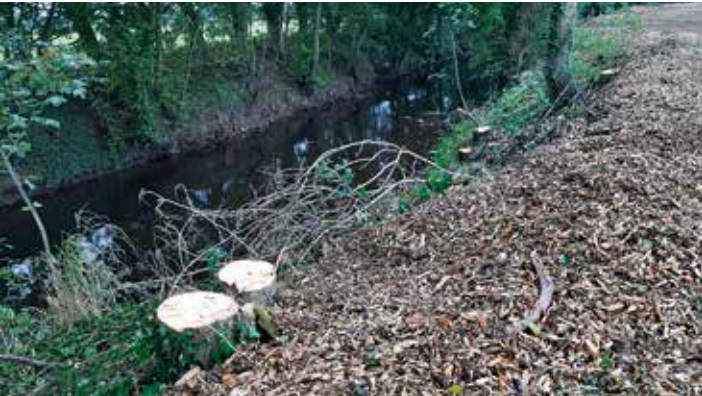
All brash was chipped. On completion of the felling the field was cleared of all brash and racked over.

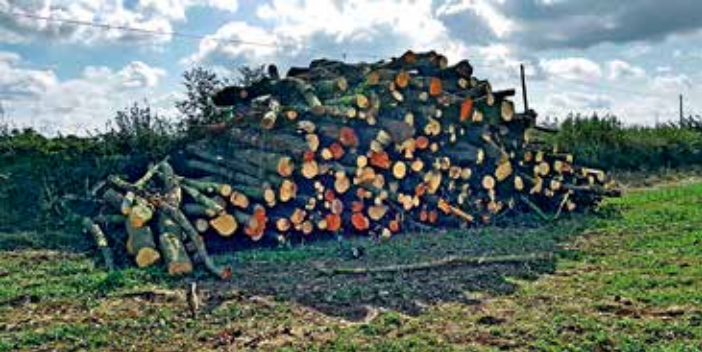
Timber stack from the felled trees is made ready for removal by road.

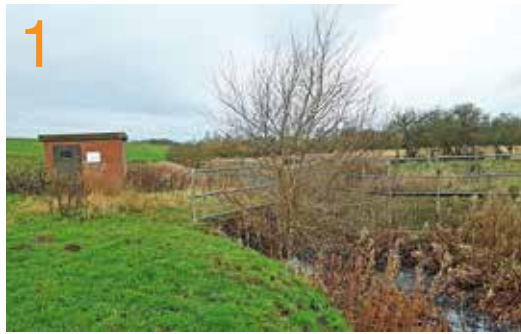
Woldgate Gauging Station.

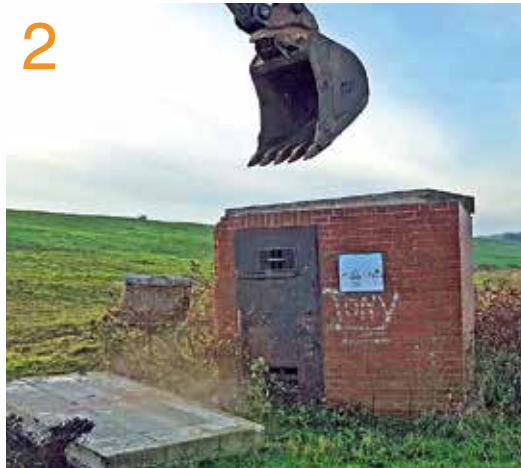
Demolition of the meter building and associated stilling well.

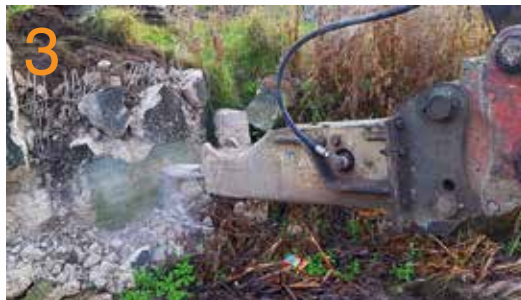
As with all similar gauging weirs the structure is built using re-enforced concrete.

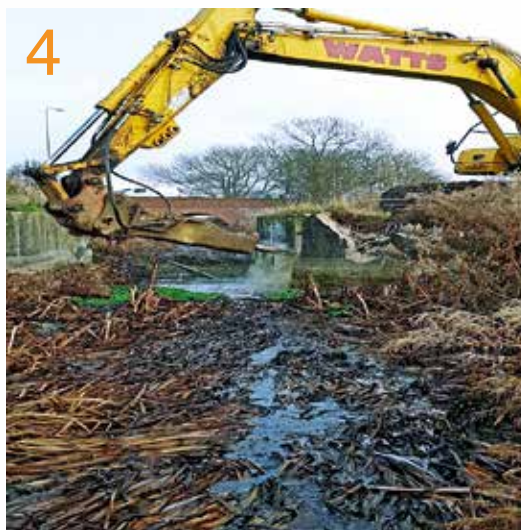
The method chosen to demolish this type of structure is with the use of a hydraulic breaker attached to an excavator.

The re-enforcing wire is toughened steel and has a high resistance to any breaking force.

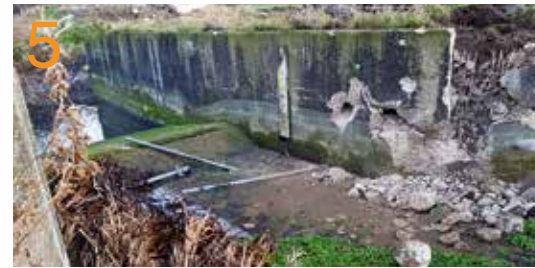
The "V" shaped gauging section can be seen on the river bed. This section of concrete was over a metre deep with many strands of re-enforcing wire. All concrete and bricks were removed from site by the contractor. This material is crushed and sorted at their site where the steel wire is recovered for re-cycling. The crushed concrete is used for roads etc.

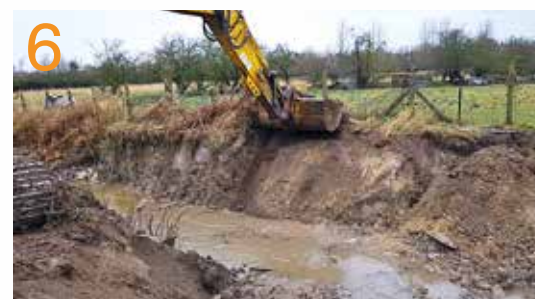
With the concrete removed the bank was reformed. The angle on this left bank needed to be left steeper than ideal. This was due to the position of the fence on the bank top. Care was needed to prevent undermining the posts.

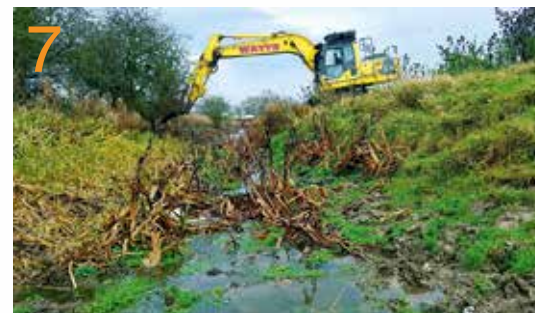
Once the weir site had been completed the landscaping part of the project began. The channel was blocked with reeds (Sparganium) that can slow river flows and cause rapid siltation.

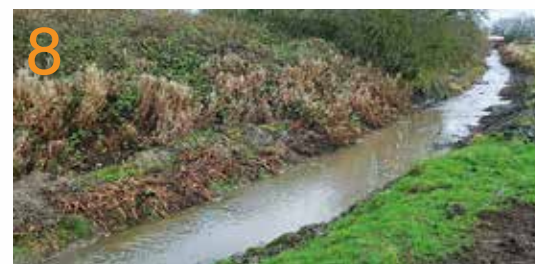
Sediment was removed from the watercourse using a method that will allow the river to meander within its restricted course. The variations made in both depth and width will assist in promoting natural geomorphological actions to develop.

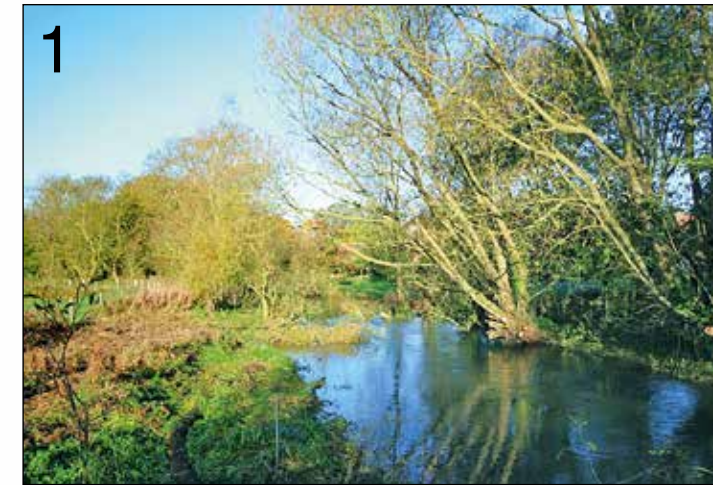
Following trimming and removal. The small willow bush on the nearside bank was part cut and hinged into the flow. This has created a meander and its associated bed scour. The large willow log was left in place as additional habitat and cover for fish.

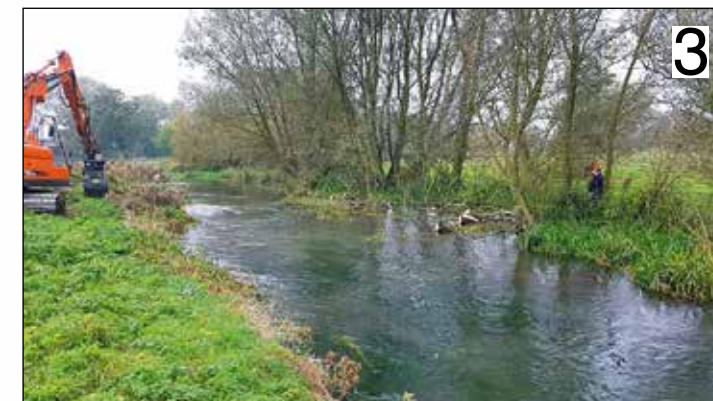
As the project progressed the river level began rising at an alarming rate making the 'in-river' work difficult to undertake with any chance of long term success. Some of the tree work would therefore need to be re-visited during lower flows.

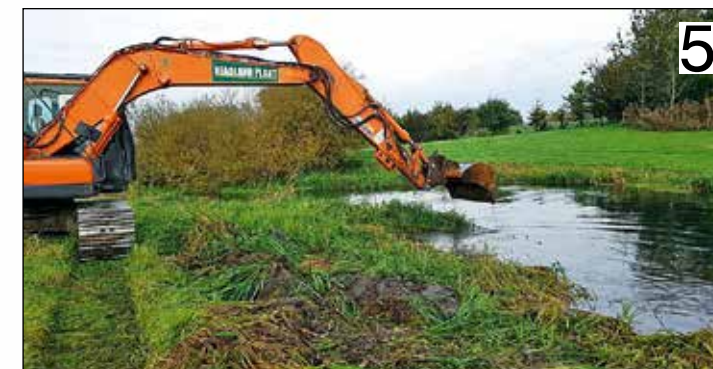
It was agreed that up to 50% would be removed to address the bank damage. This material was placed onto the remaining margin and levelled. Care was taken not to dig deeper than the original river bed.

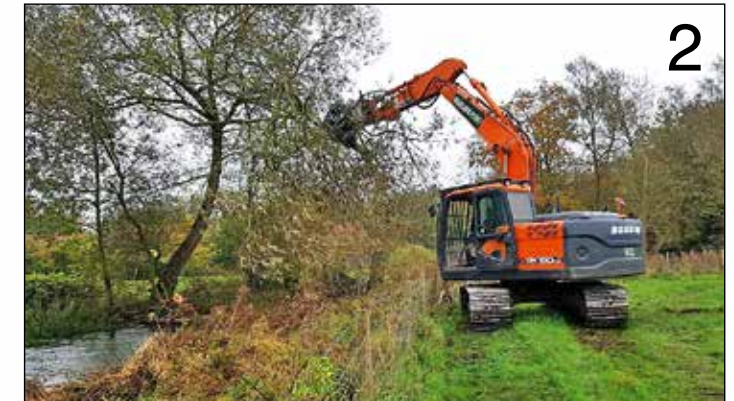
All large timber was handled by an excavator with suitable 'grab' installed. Due to the position of the bankside fence, all material had to be lifted over into a field where it could be processed.

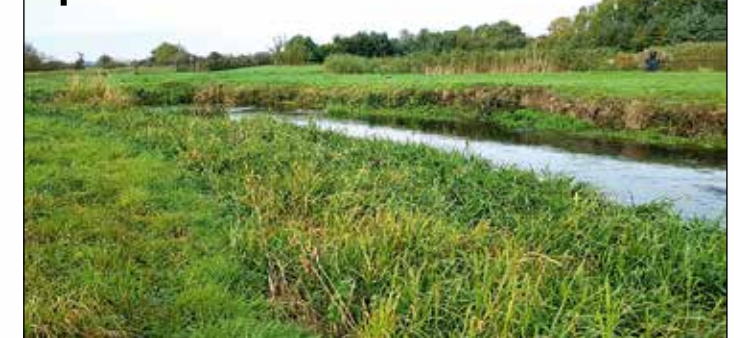
View showing wide glyceria margin and resulting opposite bank scour. The margins were managed using this method in five separate locations covering a total of 250 metres. At one specific location a grab bucket was used to great effect. This method gave improved control of the amount of material being removed.

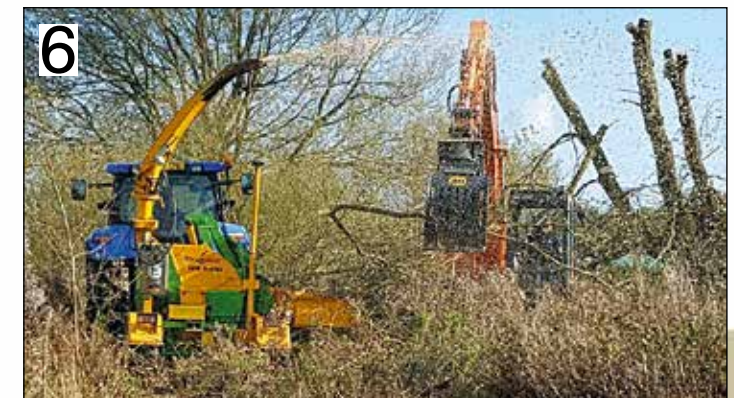
Further work on improving the large old willow trees was undertaken at Snakeholme. Our advice was to 'crown reduce' these trees. This would benefit the trees and prolong their lifespan leaving them less likely to be damaged by high winds. Five long limbs were selected and stockpiled on the bank. These will be used to create 'kickers' and placed at the foot of the riverbank to prevent scouring.

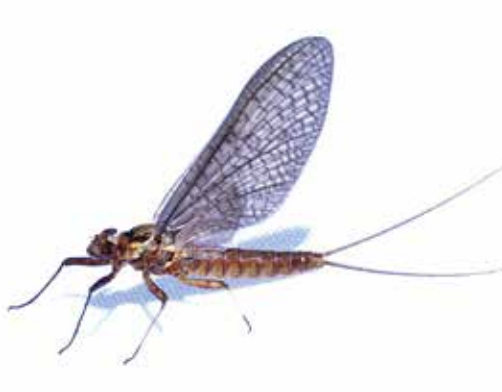
Distribution
Electrogena affinis (Scarce Dusky Yellowstreak) is very rare in the UK. Due to the limited records of this species it has been classified as ‘Data Deficient’ in the 2016 status review (Macadam, 2016). So far it has only been found in the Yorkshire Derwent catchment. It was first recorded from the Yorkshire Derwent at Norton in July 1988, only 15 metres above sea level. It has subsequently been found at several sites on the R. Rye from approximately two kilometres below Newsham Bridge down

to Rye Mouth and in the R. Derwent from just above Rye Mouth to just below Stamford Bridge.

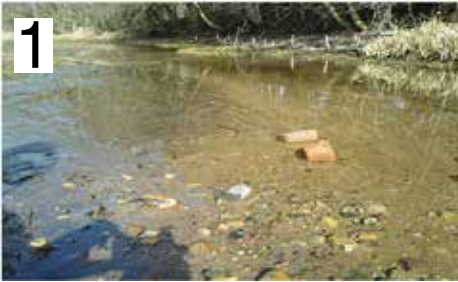
Photograph showing the over-wide and straight section during a low flow period. No cover and with compacted gravel bed.

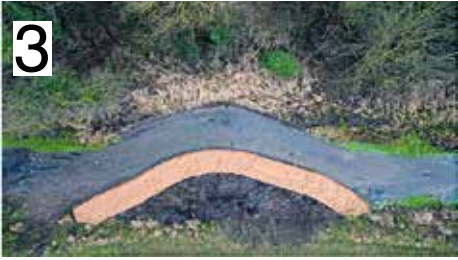
New meander at the top of the project site. The photograph is taken at a higher viewpoint to enable the full length of the meander to be shown. The stream course is about 12 metres longer when compared to its original course.

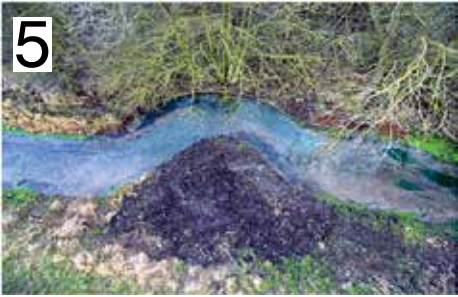
Second meander completed. The material on this site was very hard clay and needed no bank reinforcement of coir protection.

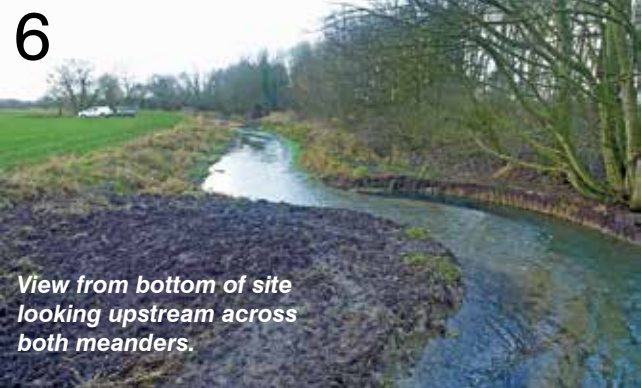
View from bottom of site looking upstream across both meanders.

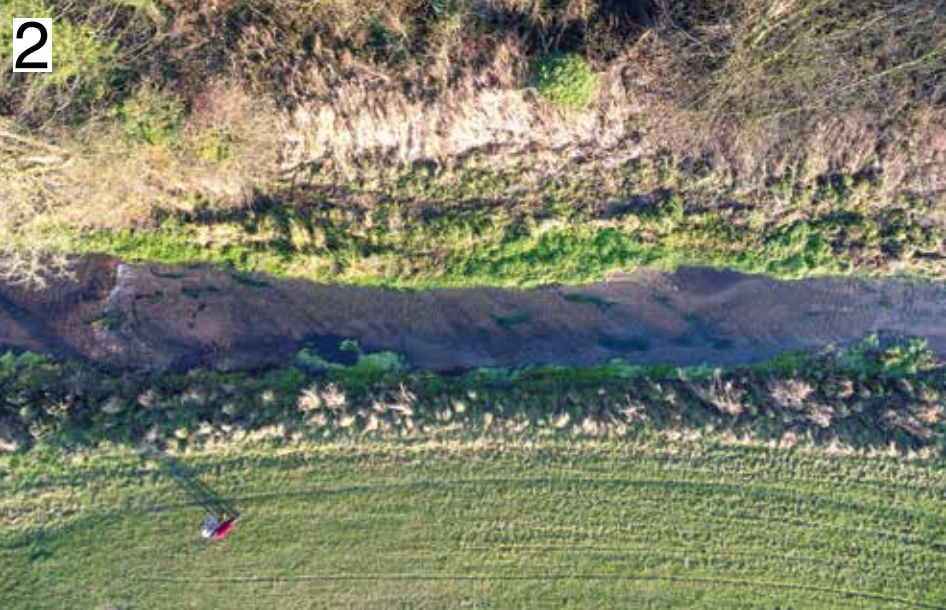
Aerial shot of the same section. Flows slightly higher but still with poor cover, straight, featureless, even bed depth and very sparse compacted gravels.

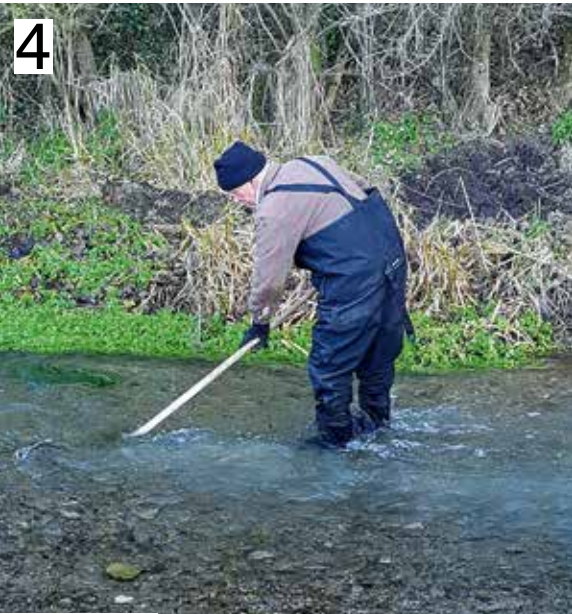
Raking the gravel and with the coir geotextile in place.
