EAST YORKSHIRE RIVERS TRUST

Newsletter 7 - July 2013

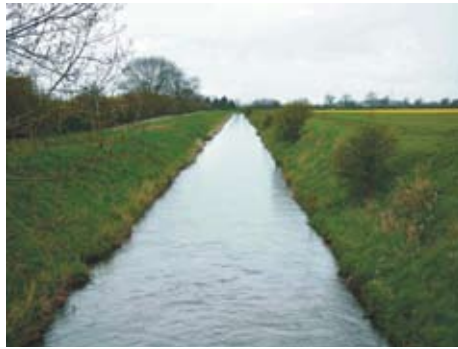
Upstream section at Brompton

Character (river channel): There are a number of common characteristics throughout the reach. The river has an almost ruler-straight (with a little kink in the middle) planform. The gradient of the bed appears very even, as do cross-sections. There appears to be a relatively constant water depth of around 0.75m during low flows. Spoil on the bank suggests the bed

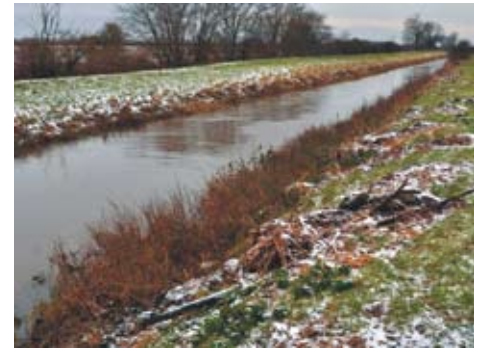
Grazed and recently dredged reeds

(*Austropotamobius pallipes*) – a protected species. It is clear any encroachment of reed from the marginal lips of the channel has been routinely curbed by dredging out and dumping on the bank. In a channel with such a uniform long and cross-section, and minimal morphological diversity, this represents a significant reduction in potential habitat that could be used for a variety of wildlife.

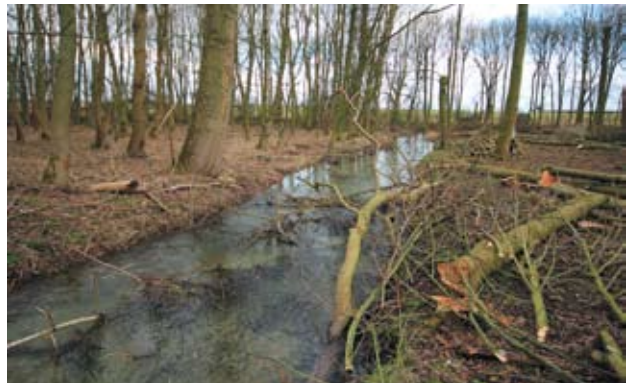
Large alder log felled into the stream creating bankside habitat

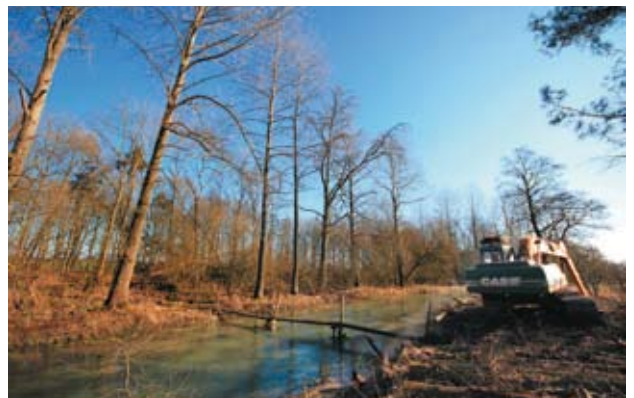
The Environment Agency provided this 22 tonne excavator to position heavy logs in the stream

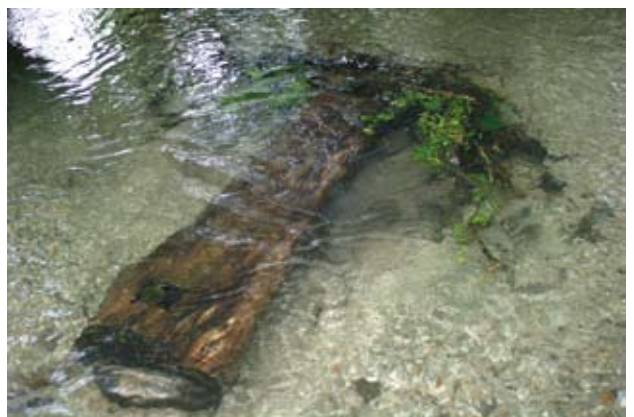
'Cover log' pinned to the stream bed to scour the gravel and create habitat for fish and invertebrates

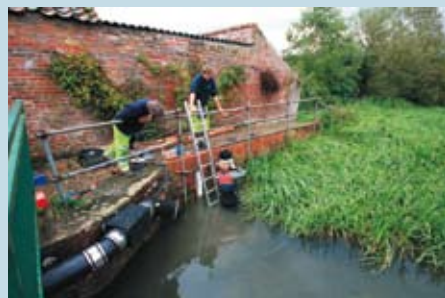
Installation above the gauging weir. View of the pass header box with the engineers fitting the cables and pipes to supply water to the pass

The submersible pump is solar powered from a system mounted on the telemetry building. All pump controls are also located within the same building.

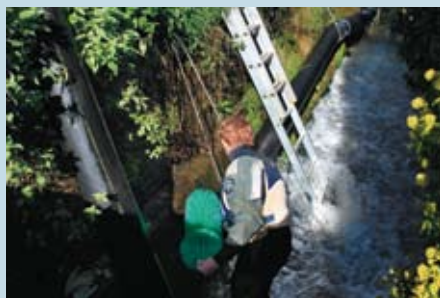
As each section of pipe was installed the media was inserted that would enable the eels to move through the pass

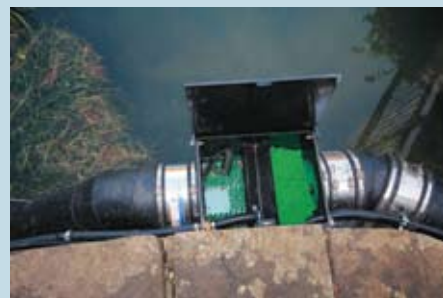
The header box with lockable lid in the open position. The camera is visible in the middle of the left hand section at the top

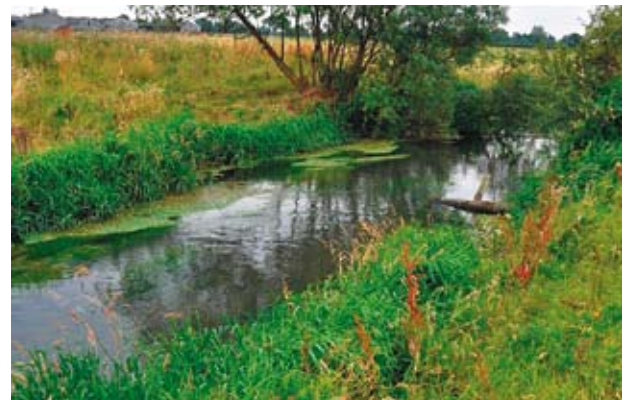
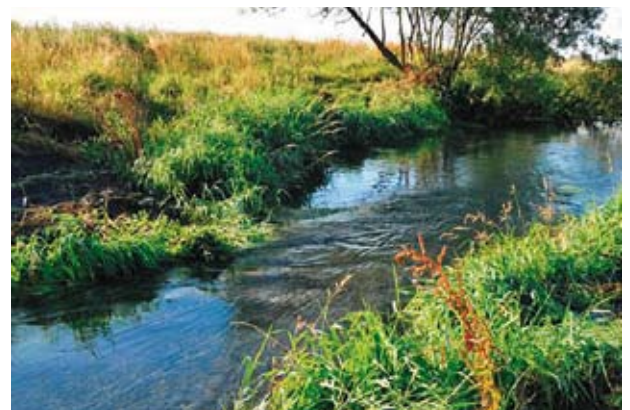
'Before and after' images showing some of the work carried out – in this case the creation of a 'run' of faster-flowing water resulting in a 'pool' below

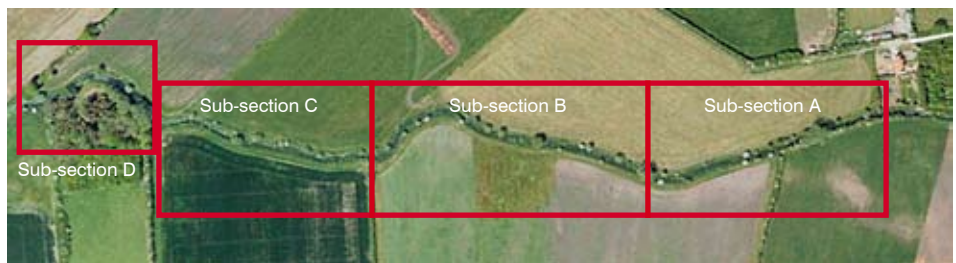
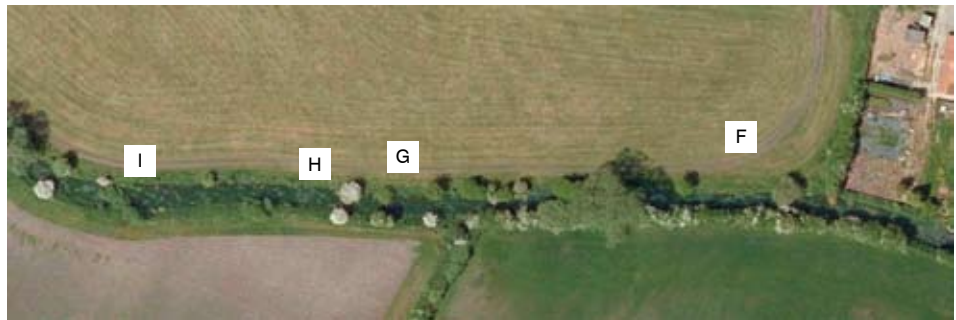
For ease of reporting, and subsequent monitoring, the location of 'features' created were pin-pointed on aerial images of four sub-sections of river. The sub-sections are shown opposite.

Features G-N are located through Sub-section A and most of Sub-section B. Here the Beck has been subject to the installation of several deflectors in attempts to clear silt and expose gravel. The gradient of the Beck is probably marginally greater here (but still only a gentle one). All these seven features created involved the formation of pools and upstream 'runs' of faster-flowing water. Most of the 'runs' were formed by a combination of pushing existing reeds into the channel to narrow the low-flow width by at least half, and back-filling the voids with material won from the re-profiling of the banks in combination with using the arisings from the pools dug downstream. What makes these seven features different is that the pool arisings contained some shale and gravel, the best of which was used to raise the bed of the Beck where it had been narrowed upstream; this results in a better head difference on the bed between the 'run' and pool, and thus should ensure the pools remain deep and scoured of silt in perpetuity. One of the features, K, also had stakes driven into the bank above the pool to create an overhang in the future (as per Feature J).

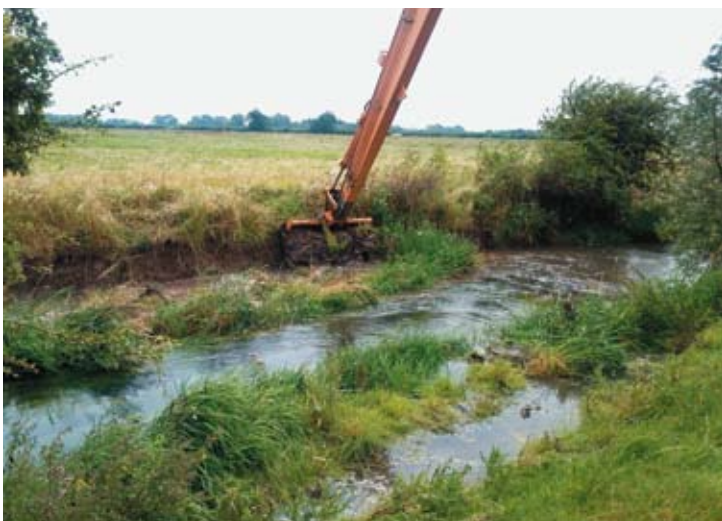
The long-reach excavator at work re-profiling the far bank and using the material to backfill the void left after dragging the reed beds into the stream to narrow up the channel
