EAST YORKSHIRE RIVERS TRUST

Newsletter 9 - July 2015

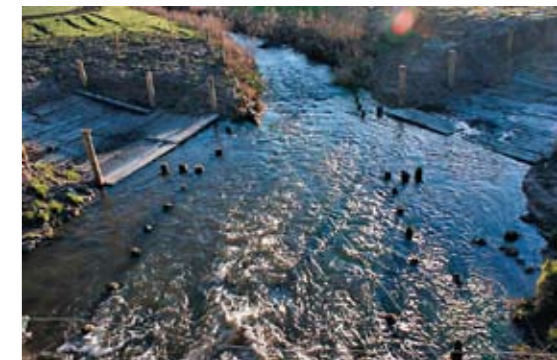
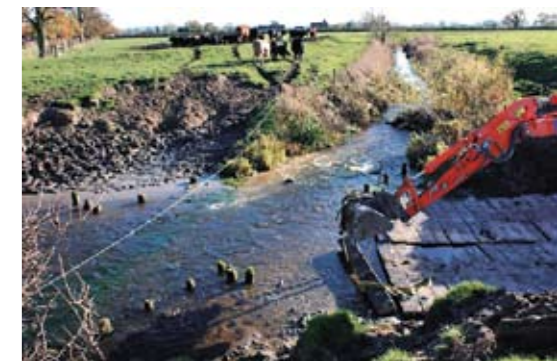
Work on installing the four drinking points commenced on the 7th of October with two water gates directly opposite one another being created on Pickering Beck where the cattle crossed the beck itself (see photographs right). Water gates were also installed on one bank of the Costa Beck and one bank of the Twelve Foot Cut. The work was completed within five working days.

To address these issues, an application was made both to Sita's Enriching Nature fund and the local Catchment Sensitive Farming officer for a project. It was proposed that these drinking areas be made permanent and the areas of bare earth addressed in such a way as to ensure little silt entered the watercourse from these locations. This involved reprofiling the river bank to ensure the access was safe (not too steep) for the cattle, excavating enough material to allow the sleepers to be inserted into the river bank to create the hard standing and installing fencing to form water gates that would withstand flood water. Sources of recycled concrete railway sleepers were found and a contractor sought who had

the required skills to construct a "water gate". Both applications were successful and the work was funded 50% from each funder. The relevant permission was sought from and granted by the Environment Agency. Local searches for all utilities were undertaken and discussions were entered into with the landowner to ensure all Health and Safety issues were addressed.

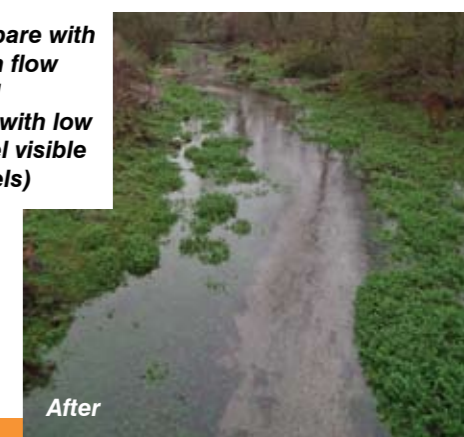
**Right: Compare with before. High flow channel still functioning with low flow channel visible (clean gravels)**

A plan was devised to create a high and low flow channel, retaining the original wide cross section, whilst creating a deeper central channel to hold a greater depth of water in times of low flows. The central channel would meander through the wide cross section, to increase stream bed variability. Green engineered solutions would be used with large woody debris and coir logs installed at appropriate locations.

Once completed a sinuous central channel would naturalise with a wide original channel holding high flows as before, but critically the low flow water would be held in the newly created central channel, providing greater water depth for a longer period. This will increase habitat

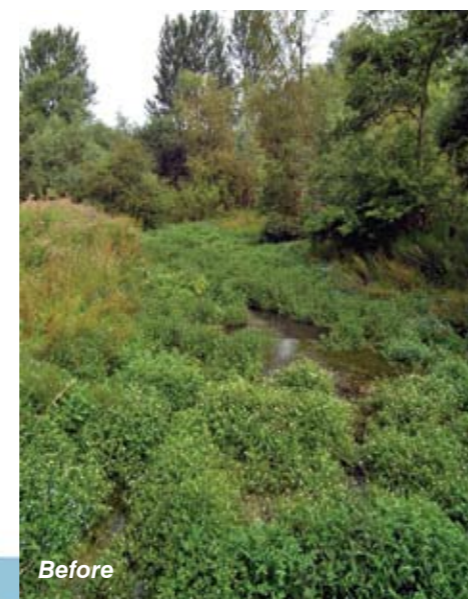
Before

Wide weed covered channel u/s view - autumn 2014

The channel in question forms one of the first feeder streams emanating directly from springs rising at the Springwell farm site. Over time the channel has become over-wide and when flows subside as the springs drop a very shallow water depth occurs with subsequent increased aquatic

weed growth. By late summer/early autumn the stream is largely dominated by extensive beds of Fool's watercress with pooled water and minimal biodiversity.

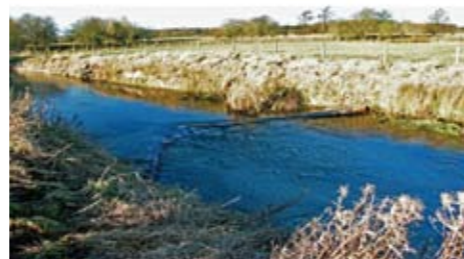
**Upstream pointing 'V'. This structure has been used on a featureless section with even bed and water depth. The 'V' will create scour in the centre channel. The material displaced will form a gravel riffle with naturally sorted gravel sizes that will benefit trout spawning and invertebrate habitat**

The aim of the project is to create areas of flow diversity and scour by the introduction of large woody debris. This method of silt control has been used in many areas and is accepted by most conservation bodies as a sustainable way of establishing a natural 'self-cleaning' flow characteristic within the channel.

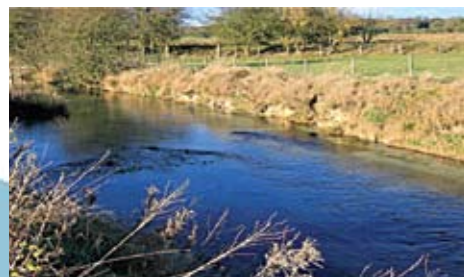
View looking at the top of the site showing erosion to the left bank

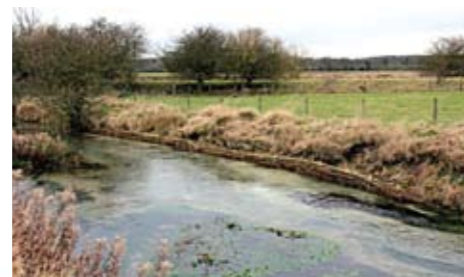
Willow spiling used to protect the toe of the eroded bank. The small island has been retained to maintain the narrow channel and both banks have been protected from increased erosion

The gravel bed will be loosened and any material gained will be used to enhance the narrowed meandering low flow channel. The undercut banks on each side of this section will be protected by green-engineering methods applied to the toe of the bank.

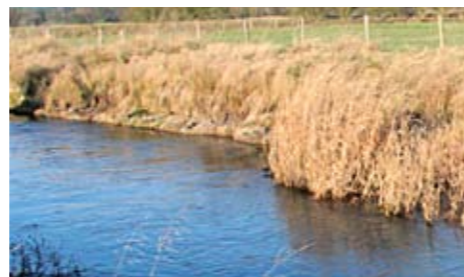
Bank toe protection using coir rolls. The rolls are staked and backfilled to promote natural plant growth from seeds present in the river sediment

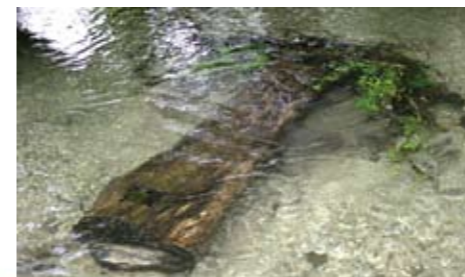
Picture above showing a cover log. These are made from large diameter logs cut in half and fixed to the stream bed on spacers (legs) that create a gap beneath the log

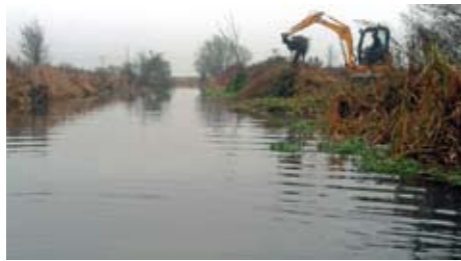
**Backfilling of new 'D' shaped submerged berm**

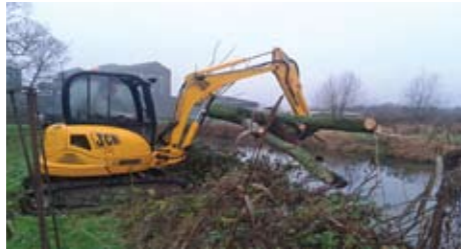
**Placing a large log close to the left bank as a deflector. A total of nine such structures were positioned through the project site. These logs were drilled and pinned to prevent any movement**

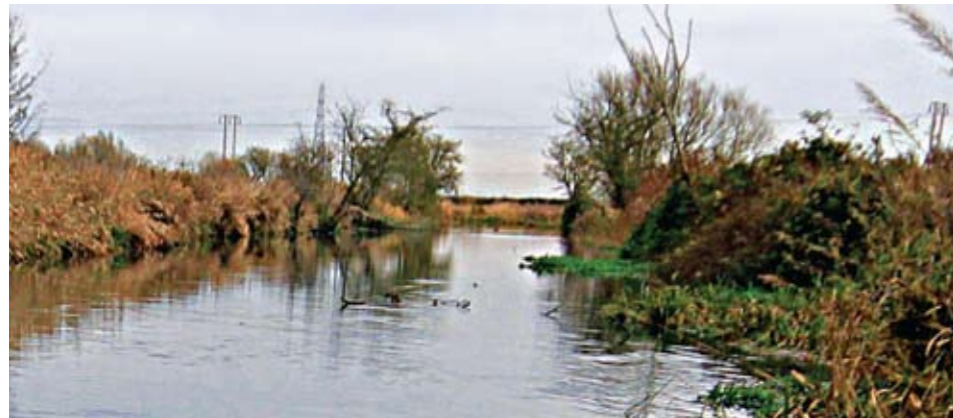
**Below: View of lower section of the project site looking towards junction pool. Hawthorn bushes on the left and right banks were dead or dying. The bushes on the right bank were felled and placed under the bushes on the opposite bank and secured using steel pins**
