Restoring the Yorkshire Derwent

River Restoration Plan

Final report
April 2010

Document title Restoring the Yorkshire River Derwent
Geomorphological Restoration Action Plan
Document short title River Derwent Restoration Plan
Status Final Report
Date April 2010
Project name Favourable Condition for the Derwent
Project number 9T5336
Client Environment Agency
Reference 9T5336/R/303521/Lond

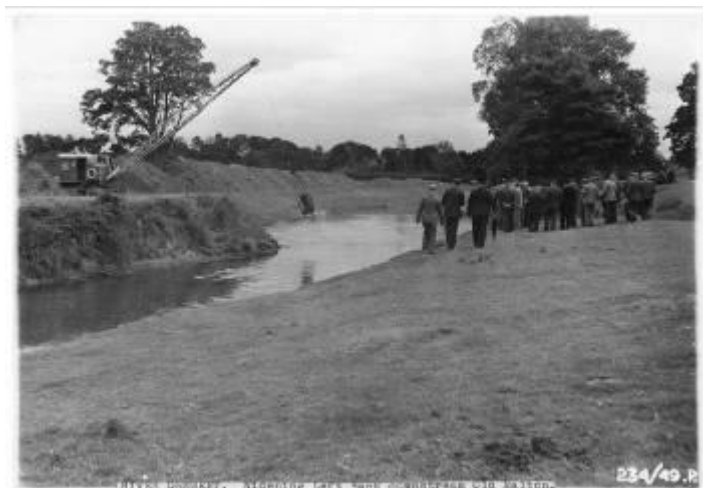
Channelisation works downstream of Old Malton in 1949 created a significantly wider river channel

A large proportion of the River Derwent channel has been historically channelised to allow navigation upstream, or to increase channel capacity. These works were undertaken along much of the river in the 1940s and 1950s, and have resulted in an overwidened and overdeepened channel (see **Channelisation and disconnection from the floodplain** for more information). Examples of the impact these works had on the river channel are shown in these photographs, which were taken while the works were being undertaken.

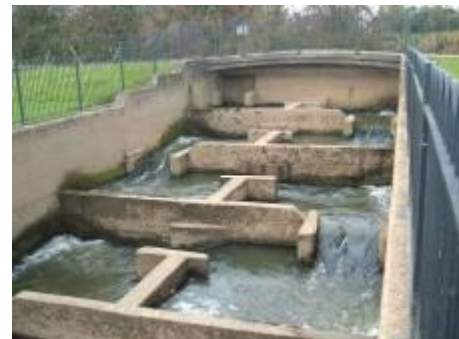
Fish pass at Elvington

The aim of this solution is to provide fish passes on structures that are currently impassable, in order to allow free movement of fish (particularly interest features such as lamprey) in the River Derwent. This measure is specifically targeted in individual reaches, but if all impassable structures are addressed this will help to improve passage in the whole river. This option should only be considered if it is not possible to remove or modify a structure, since it has limited benefits to the condition of the SSSI as a whole.

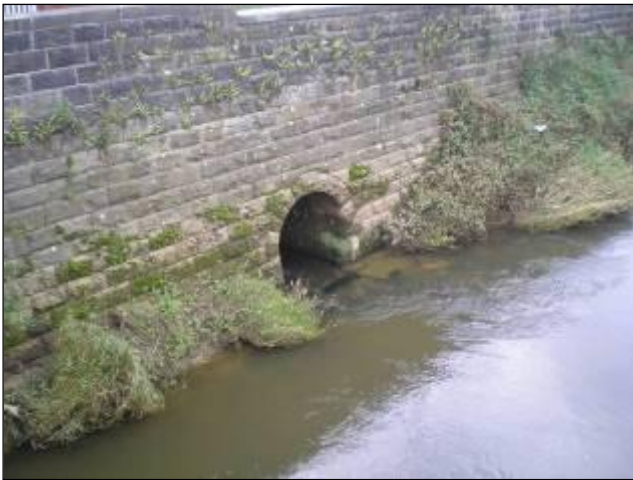
A surface water outfall into the River Derwent

The river is constrained by bank protection as it flows through Malton. Several surface water outfalls divert runoff from the town directly into the main river (see photograph). The quality of this water could potentially be improved through the introduction of a Sustainable Urban Drainage System in the town. The urbanised nature of the reach means that there are unlikely to be any significant opportunities to improve the river without compromising the needs of existing riparian land uses. The area has a high risk of flooding and a flood defence scheme was installed in 2000, and there are limited options to improve the river habitats without conflicting with this scheme. However, small areas of more natural banks could potentially be enhanced to improve habitat quality (see photograph). In addition, previous surveys have suggested that the channel around the island at Malton Road Bridge provides good habitat for water crowfoot and other plant species, and this should be preserved.

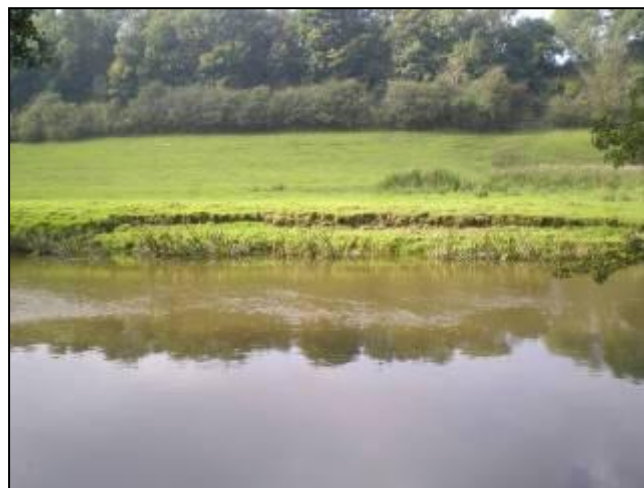
A collapsed section of the right-hand bank along the River Derwent

The River Derwent follows a relatively straight course in this reach, with uniform channel and flow conditions and a deep bed. This lack of diversity is likely to have been caused by historical dredging for navigation purposes. The right bank of the channel has been affected by cattle trampling, has collapsed in places, and is lacking in bank-top shelter and marginal habitats (see photograph). Himalayan balsam, an alien invasive plant, is extremely prevalent in this reach, particularly on the left bank. The trampling and bank collapse provides a good opportunity to produce a more varied bank profile which supports a wider range of riparian and emergent habitats. These habitats could develop if areas of trampling were fenced off to prevent cattle access and allow them to revegetate. Shelter and shading could also be increased through the planting of trees and other suitable plants on the bank top. In addition, the amount of sediment supplied from Menethorpe Beck could be reduced to contribute towards catchment-wide measures aimed at reducing sediment supply to the main river.

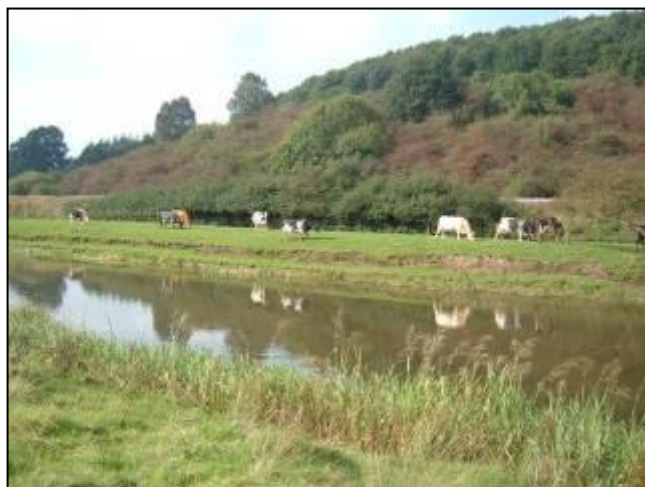
Cattle trampling has partially reprofiled the steep banks

The River Derwent follows a meandering course, in which individual reaches have been straightened and channelised due to the construction of a railway line adjacent to the river. As a result, the channel is deep and uniform, and offers little variety in terms of physical habitat and flow conditions. Parts of this reach have been heavily trampled (see photograph), which has allowed the development of good areas of marginal habitat in places. Trampling has helped to reprofile the banks, and has created shallow areas that are ideal for the development of marginal and emergent habitats. The river could be enhanced if these areas were to be fenced off to allow them to revegetate naturally. In addition, the amount of sediment supplied from the tributaries and surrounding land could be reduced to contribute towards catchment-wide measures aimed at reducing the supply of fine sediments. Soils are reported to be particularly erodible, so solutions to reduce sediment supply should be targeted in this reach.

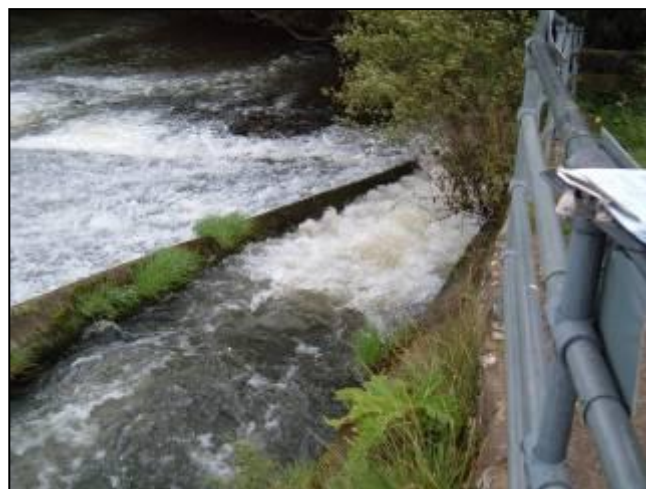
The fish pass at Kirkham Weir, which is currently unsuitable for many fish species

The River Derwent flows along two large meanders in this reach. Towards the upstream end of the reach, the channel splits around a small island. Kirkham Weir is located on the right channel, and a set of sluices are located on the left channel. The weir is old, is currently in a relatively poor condition, and includes a fish pass that is not suitable for coarse fish and lamprey species (see photograph). The weir creates turbulent flow that cleans fine sediments from the gravels, which has created good habitat for barbel, bullhead and water crowfoot downstream of the structure. Kirkham Sluices are located on the left channel, and used to help manage flood risk further downstream. The soils in this reach are easily erodible, and work to decrease sediment supply will be beneficial. The reach would also benefit from improved fish passage, either through replacing the fish pass on the weir or changing the way the sluices are operated. The left bank upstream of Kirkham Bridge has excellent marginal habitats, and these should be retained if the banks are reprofiled.

D.1 D.2 D.3 D.4	Investigate the feasibility of removing or modifying Kirkham Weir, modifying the operation of the sluice, or modifying the fish pass	In-channel structures	<p>Kirkham Weir causes considerable impoundment upstream, and the SSSI would benefit from removal of the structure. The feasibility of removing the structure should be considered in the first instance. This action may need to be combined with upstream river restoration</p> <p>If removal is found to be unfeasible, options to modify the structure or alter the operation of the adjacent sluices should be explored. If all these options are not feasible, the existing fish pass could be modified or replaced to make it suitable for a greater range of fish species.</p>

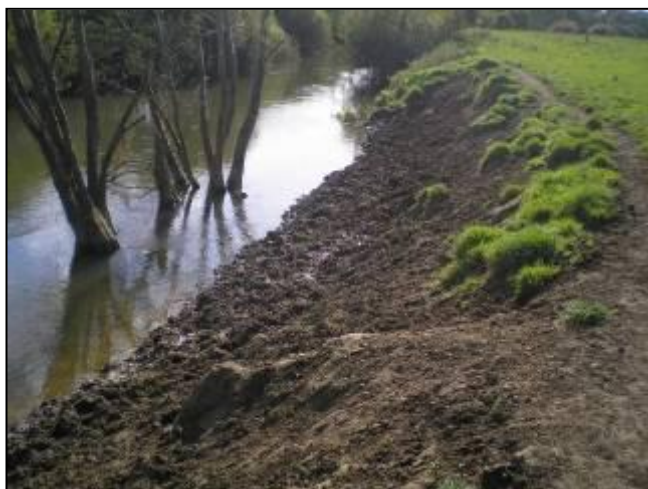
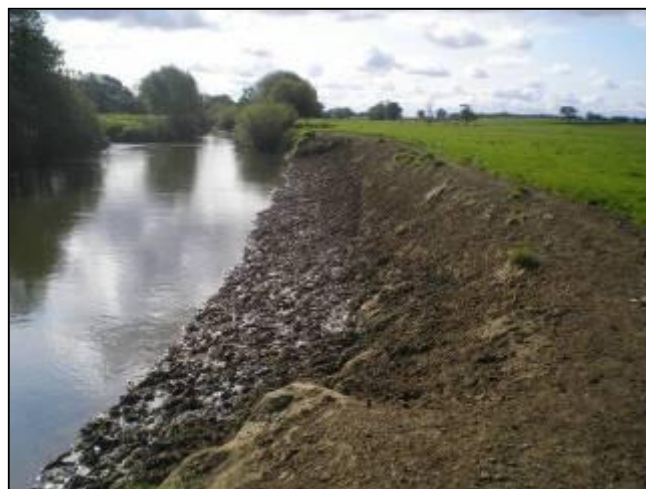
Heavy trampling along the left bank of the River Derwent

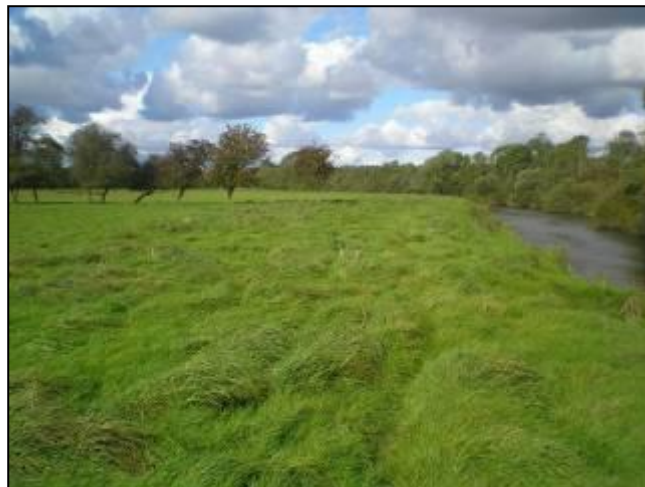
Much of the right-hand bank is exposed and lacking in bankside vegetation cover

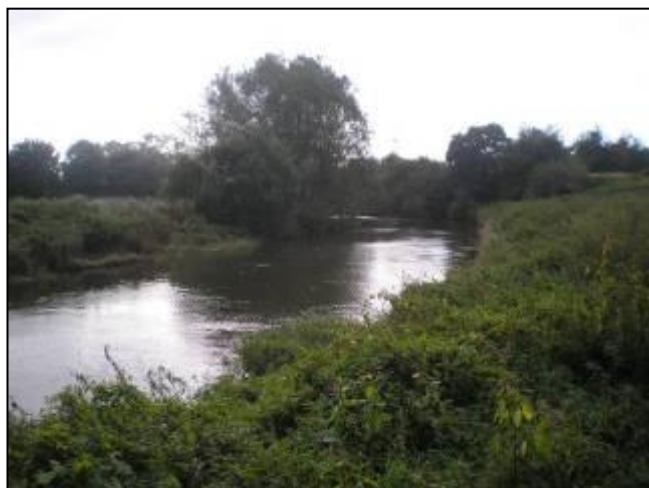
The banks are generally steep, and do not provide the opportunity for marginal habitats to develop

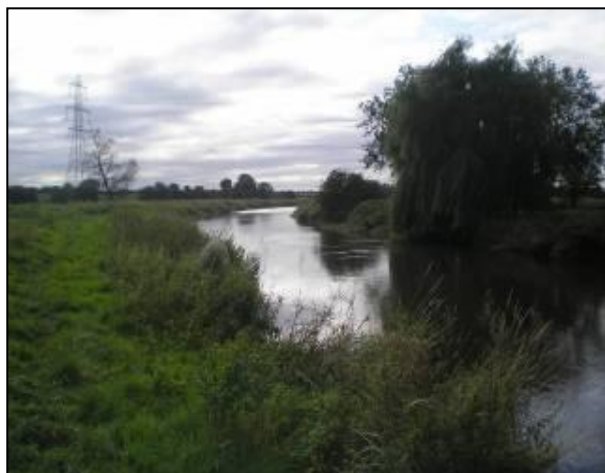
The embankment on the left-hand bank of the river

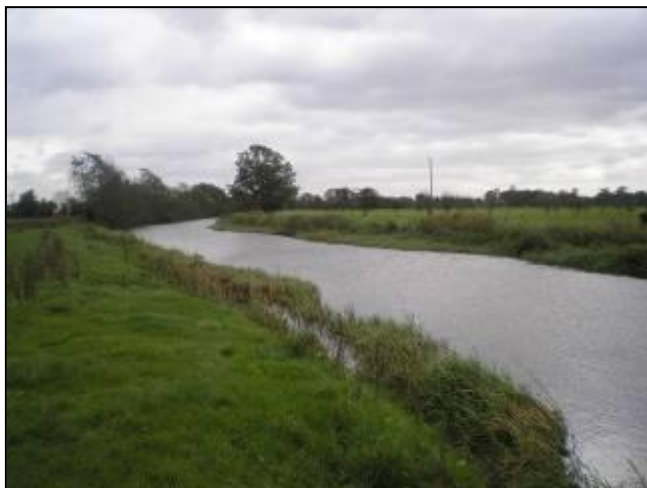
The banks downstream of the water treatment works, which have very little tree cover

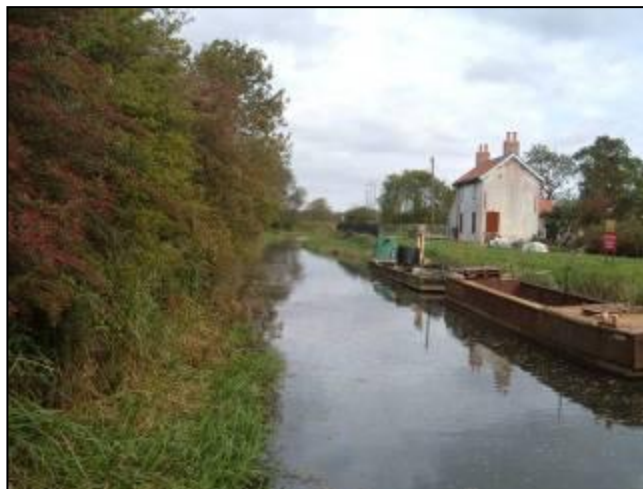
The channel at Sutton Lock, which provides good nursery habitat for lamprey
